# Corrosion

OFFICIAL PUBLICATION  
NATIONAL ASSOCIATION OF CORROSION ENGINEERS

March, 1946

# Corrosion of Yellow Brass Pipes in Domestic Hot-Water Systems—A Metallographic Study

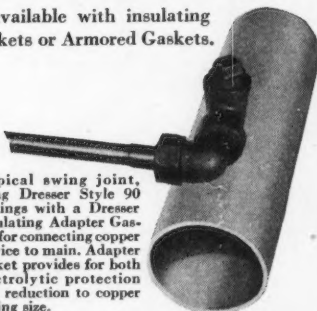
Typical swing joint, using Dresser Style 90 Fittings with a Dresser Insulating Adapter Gasket for connecting copper service to main. Adapter gasket provides for both electrolytic protection and reduction to copper tubing size.

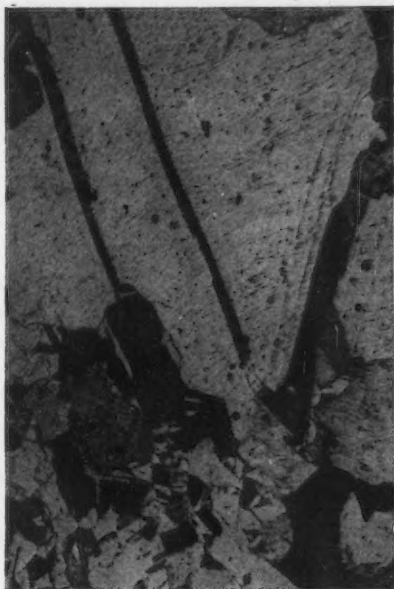
Figure 3—Inhomogeneous grains of alpha, pipe No. 66.  $\times 200$ .

1. Coarse primary structure, not entirely eliminated by annealing, as evidenced by Widmannstätten pattern of alpha and beta arrangement.
2. Striking variations in grain size (Figure 3).

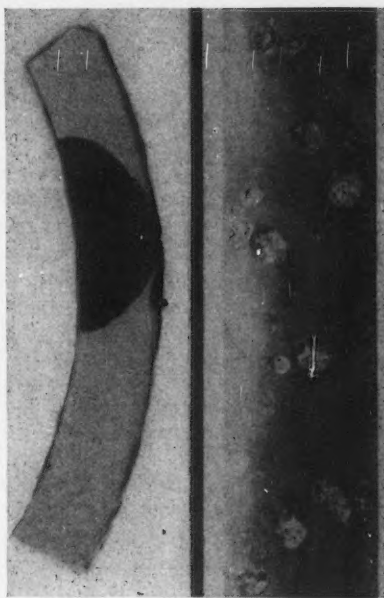
Figure 4

Figure 4—Plug in pipe 66.  $\times 3$ .

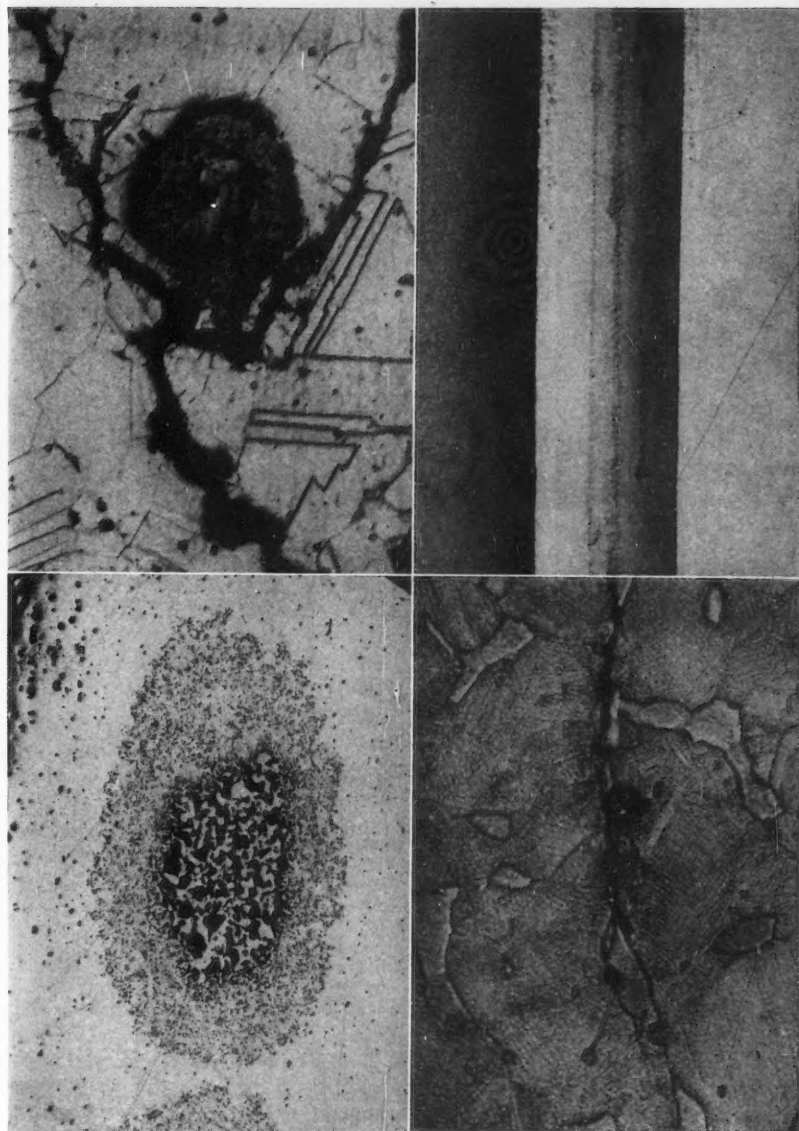
Figure 8—Upper left: Incipient plug at fork of cracks, pipe 53.  $\times 300$ .  
 Figure 9—Upper right: Parallel rows of tubercles, pipe 24. Natural Size.  
 Figure 10—Lower left: Oval section of plug, pipe 200D.  $\times 30$ .  
 Figure 11—Lower right: Slip bands and crack, pipe 149.  $\times 750$ .

1. Incipient plugs were found within pipe walls at the end of cracks (Figure 8). The metal surrounding the plugs obviously had

The processing of brass pipes involves cold-working, all traces of which are not always removed by the subsequent annealing. Some grains of pipes often showed a distortion of shape or presence of slip bands—a distinct proof that the stresses had not been entirely eliminated. Microscopic cracks found in the walls of some pipes are also significant (Figure 11). As they fre-

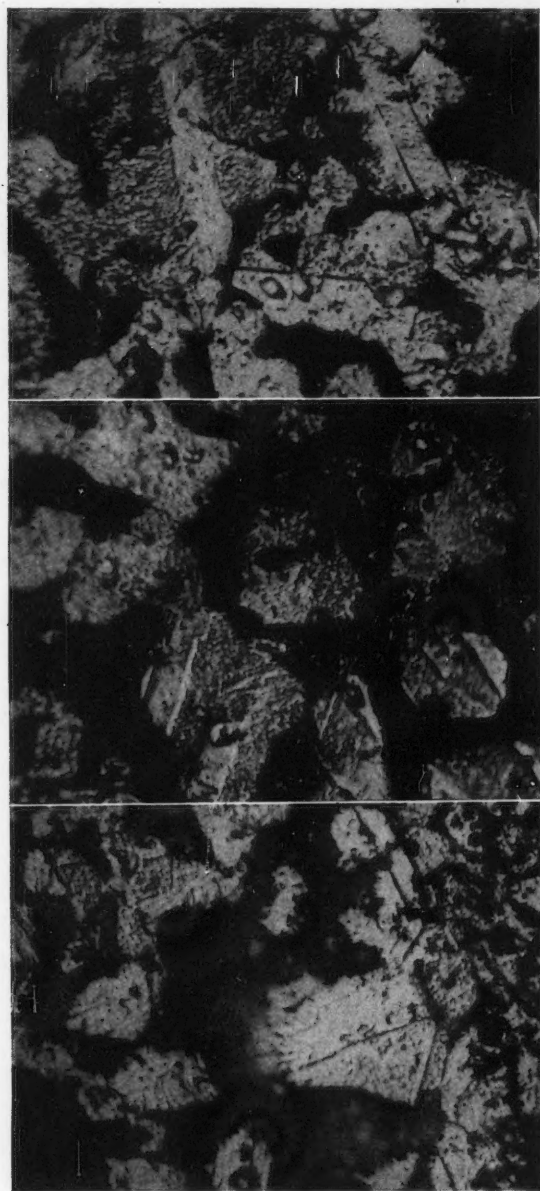
Figure 12—Twins of former alpha in copper plugs.

In the plugs of alpha-beta brass pipes, both constituents were completely replaced by copper but were not entirely merged. The "alpha" in plugs of pipes 5, 7H and 54, which were all made of alpha-beta brass, clearly showed twinning in some of the alpha grains now completely replaced by copper. In other Muntz-

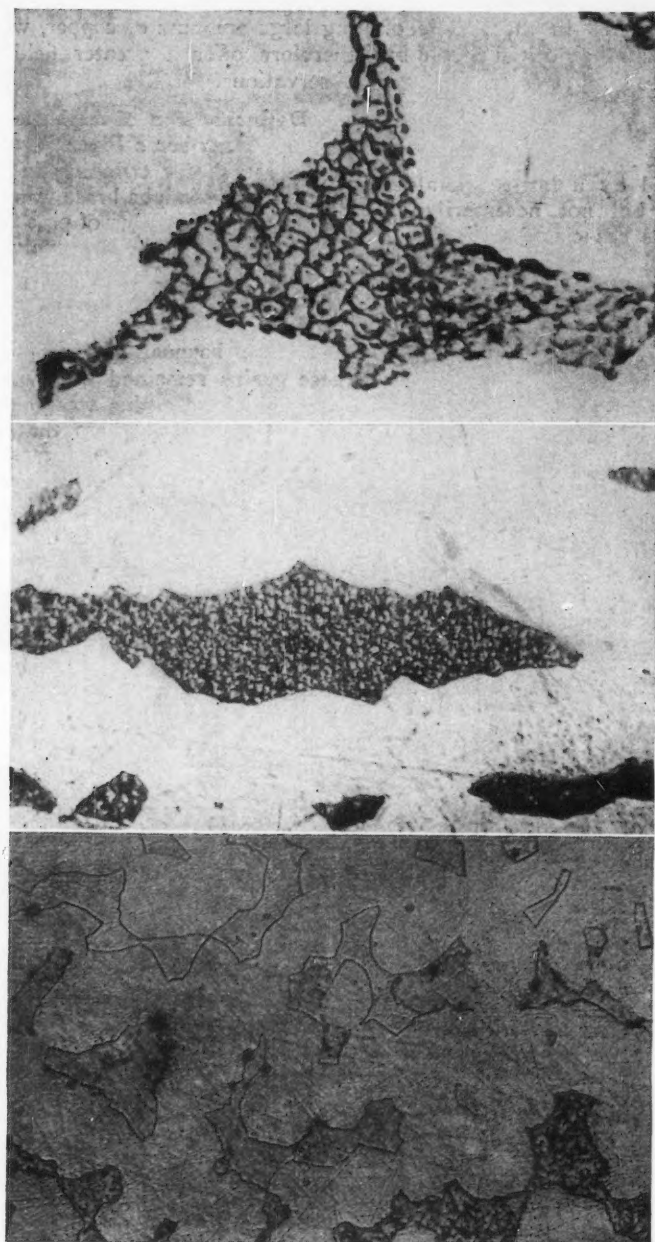
Figure 13—Dezincification of beta.

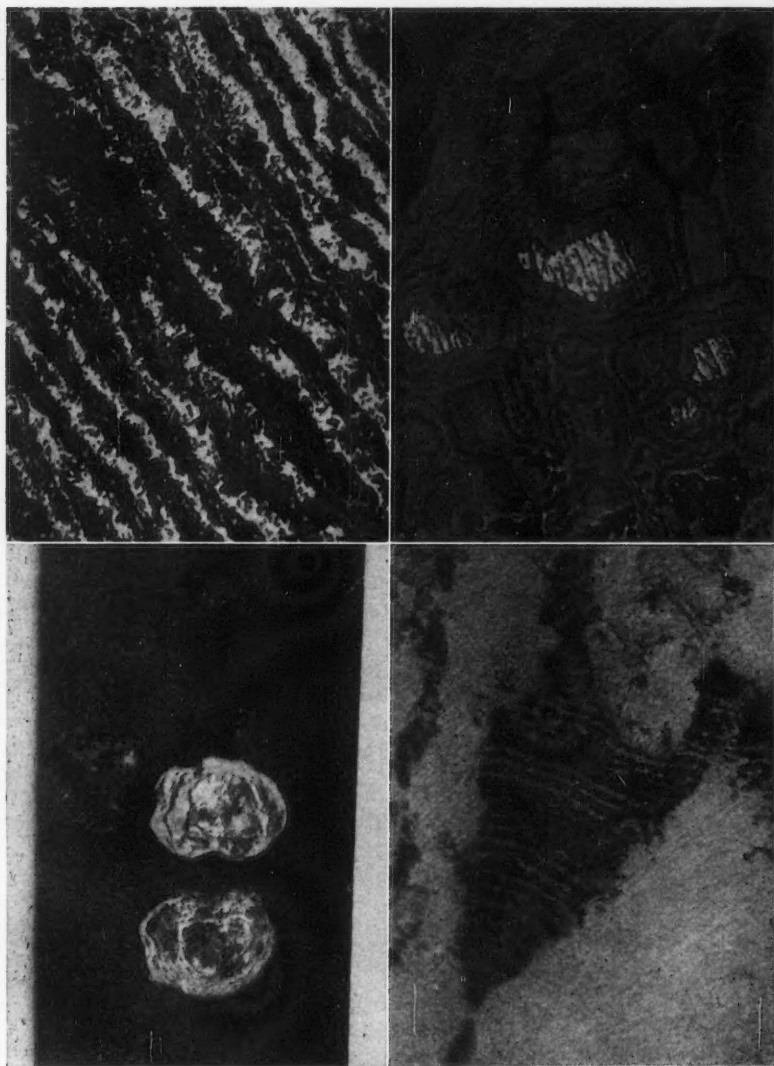
Figure 14—Periodicity of corrosion.

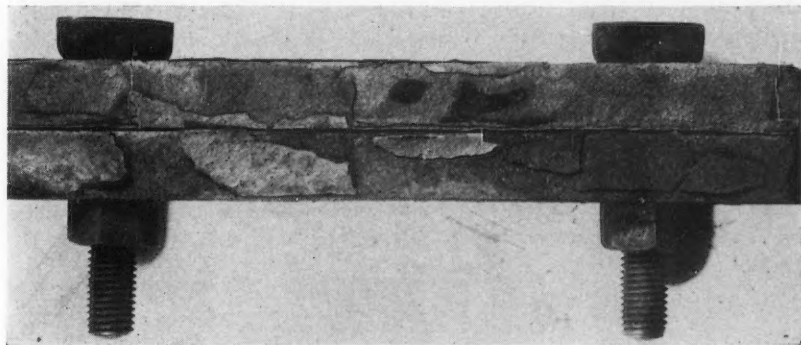
Figure 4—Plain cast iron bars bolted with alloy cast iron bolts and nuts after exposure in acidified salt solution.

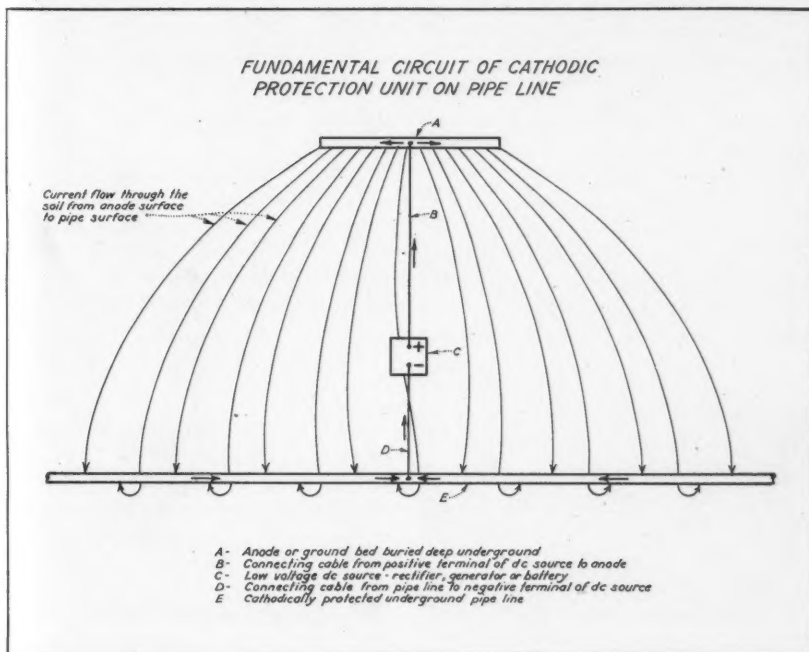
Figure 22—Fundamental circuit of cathodic protection unit of pipe line.

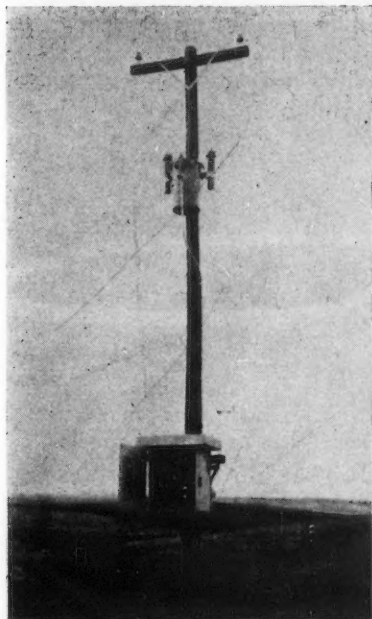
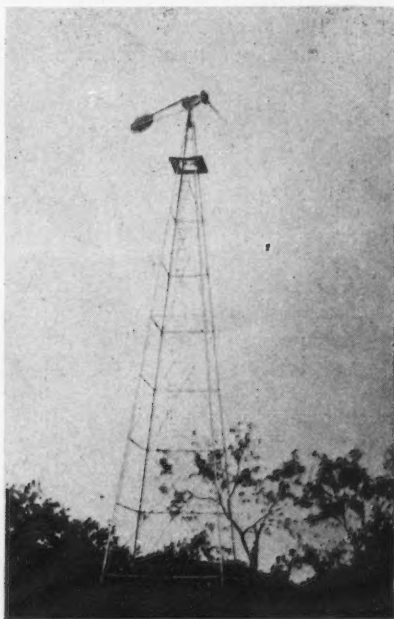
Figure 24 (Left)—Typical rectifier installation. (Right) Typical wind generator installation.

Thermo-ionic type rectifiers include the heated filament and the Ignatron units. The filaments have a limited life of about 1,000 hours, so replacements are frequent where a number of units operate continuously. The Ignatron is a new de-

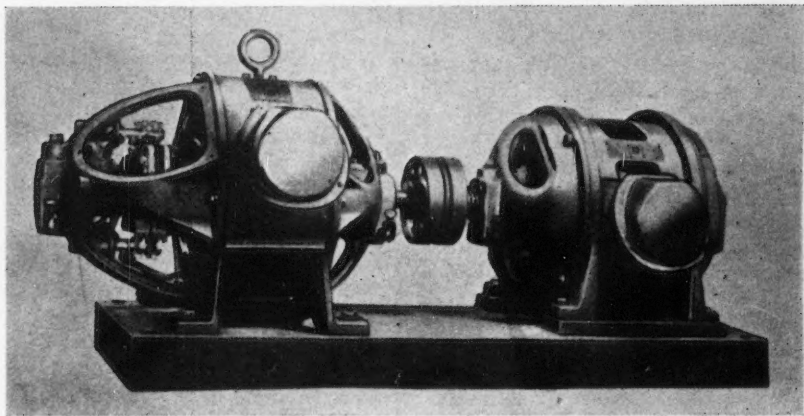
Figure 25—Motor-generator unit without mounting accessories.

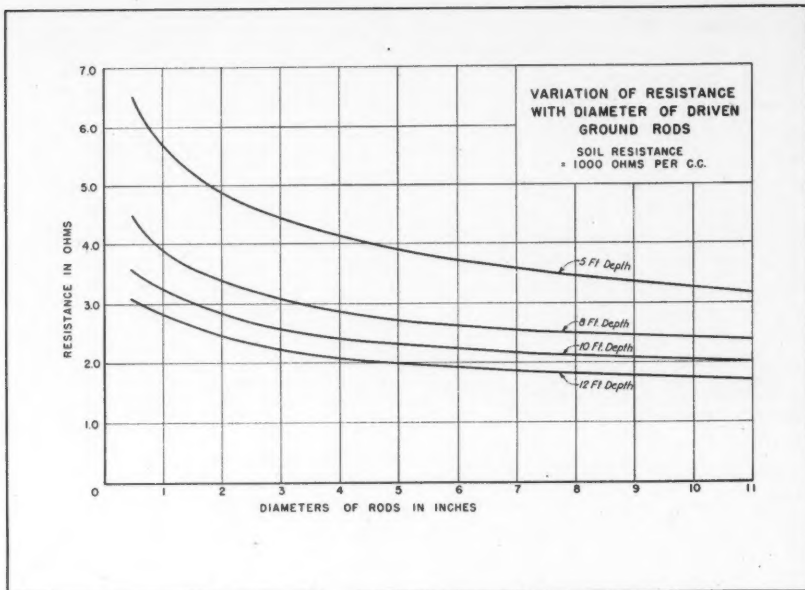
Figure 27—Variation of resistance with diameter of driven ground rods.

**Driven or Vertical Rod Anodes:** Where driven rods (or tubes) are used as anodes, their ability to transmit current to the soil depends upon the depth to which they are driven and upon their diameter. As the depth of a rod of fixed diameter

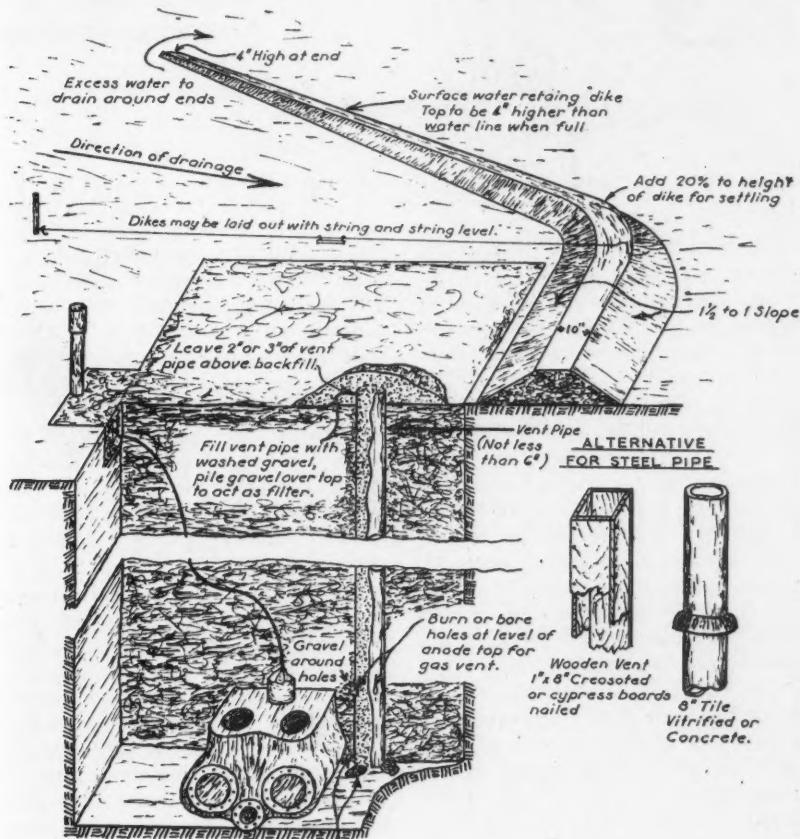
Figure 33

Set vent pipe near anode but do not allow steel pipe to make contact with anode. Place two or three rocks or pile of gravel under vent pipe to keep bottom open for water flow.

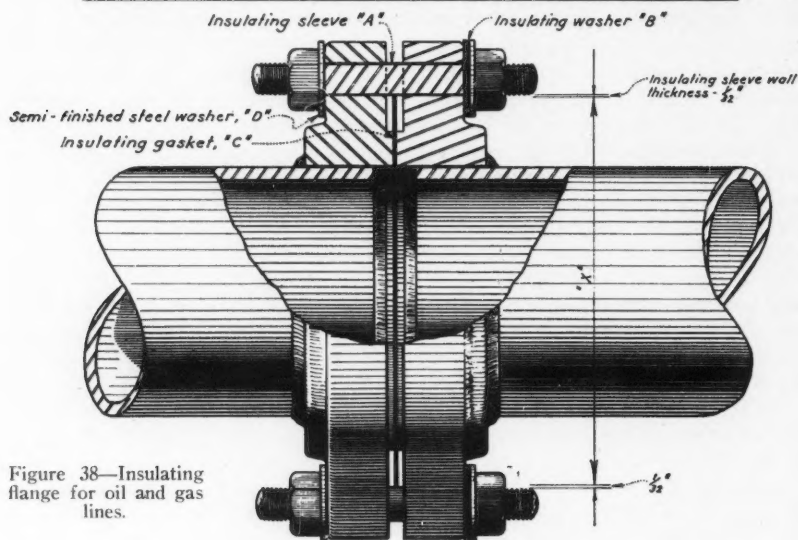
Figure 38—Insulating flange for oil and gas lines.

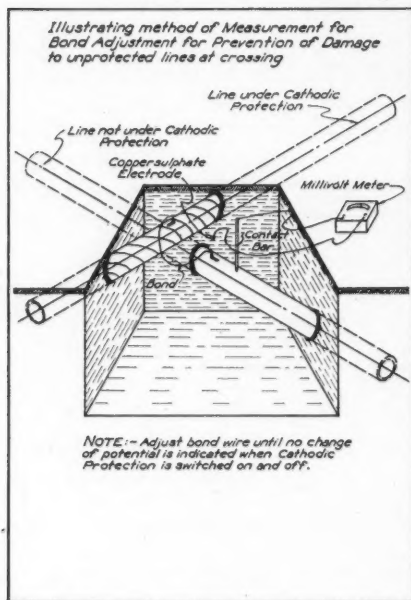
Figure 40—Method of measurement for bond adjustment for prevention of damage to unprotected lines at crossing.

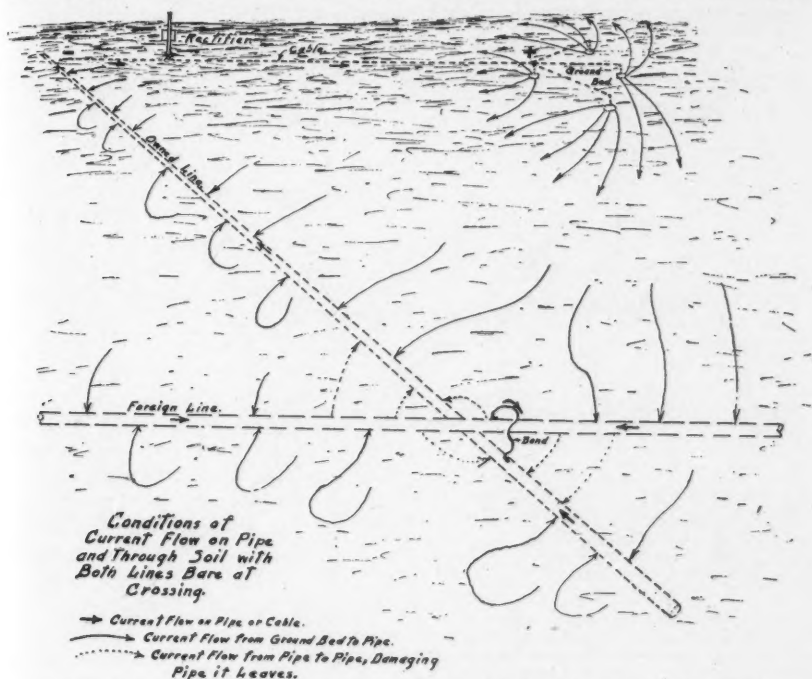
Figure 41—Conditions of current flow on pipe and through soil with both lines bare at crossing.

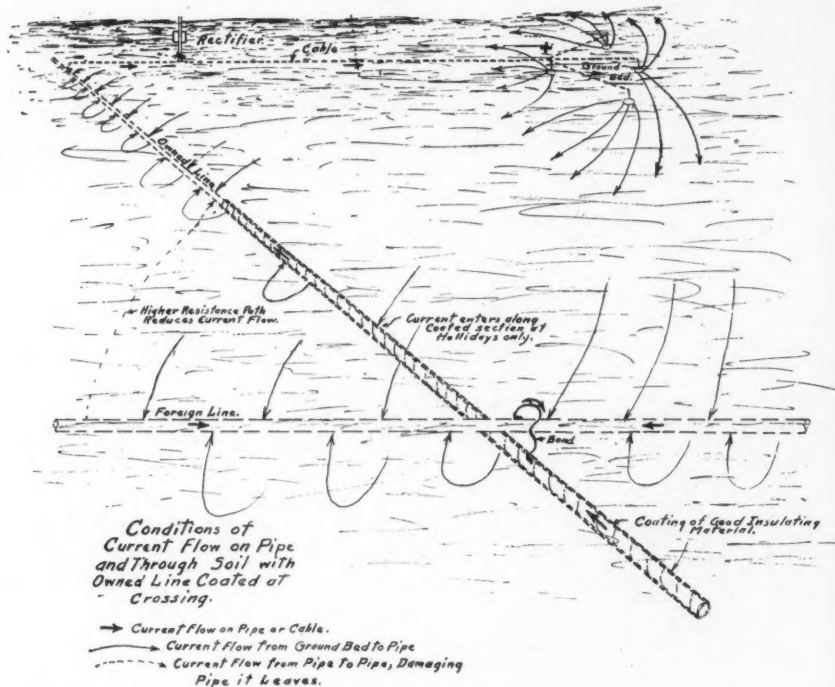
Figure 42—Conditions of current flow on pipe and through soil with owned line coated at crossing.

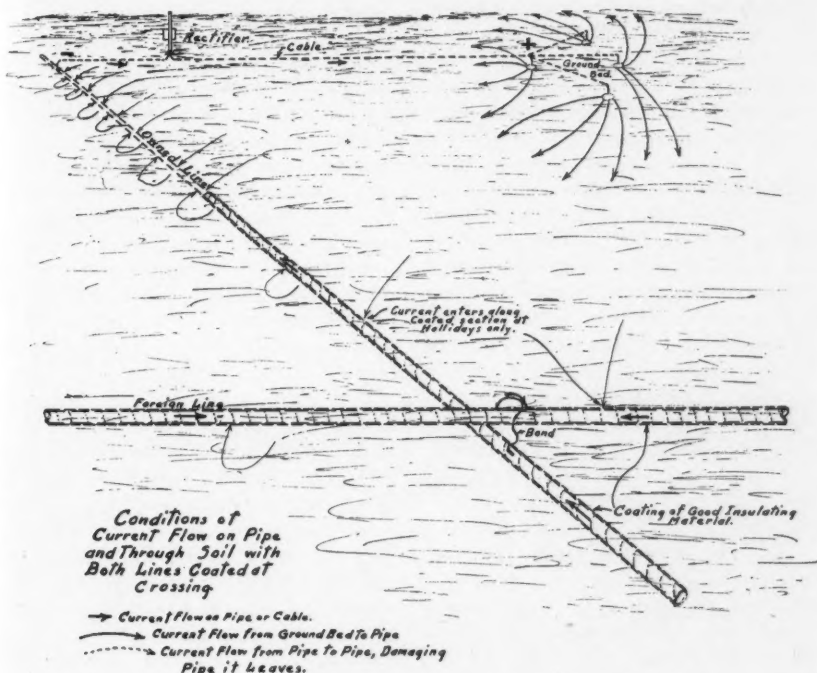
Figure 43—Conditions of current flow on pipe and through soil with both lines coated at crossing.
